Steel City Home Inspections

Report #: RE21707

KEY TO THE INSPECTION REPORT

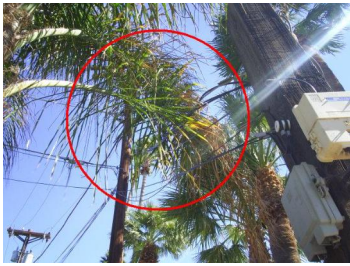
03. Grading

Vegetation was in contact with the exterior walls. The vegetation should be trimmed away to prevent damage to the building. * (3) Palm branches that are touching electrical lines in the back yard should be trimmed away to prevent damage.

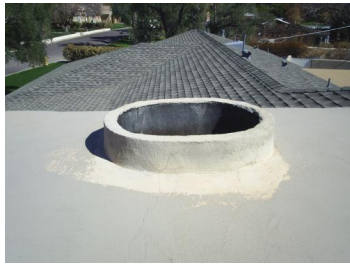
09. Chimney(s)

Recommend the installation of a rain cap with approved spark arrestor. *

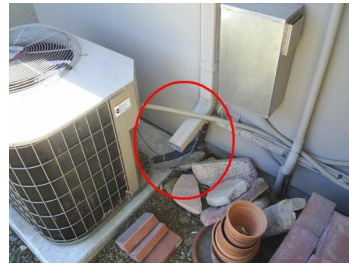
11. Gutters & Downspout:

Recommend gutter downspout terminations be routed away from the building. *

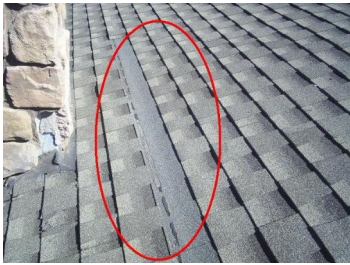
20a. Shingle / Shake

Missing and damaged shingles were noted at time of inspection, by chimney area. (2)

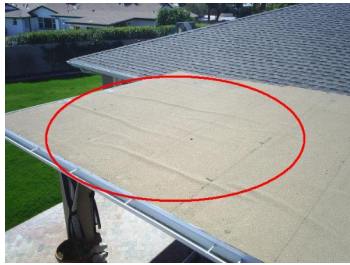
21. Built-up / Low slope

Roofing materials appear to be nearing the end of their useful service life. (2) The roof covering showed signs of blistering and prior patches at the time of the inspection. (2)

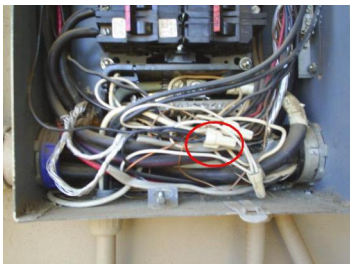
43. Panel Notes

Improper wiring at: Main panel splices /pigtails in main panel, starting to degrade. (2) (4) Improper wiring at: Main panel multiple wires connected to a single breaker. (2) (4) Recommend further

evaluation and repairs by a qualified professional. (2) (4)

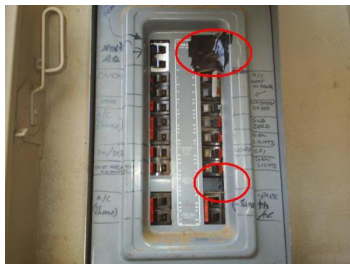
44. Wiring Notes

Unprotected openings at: Main panel. (2) (4)

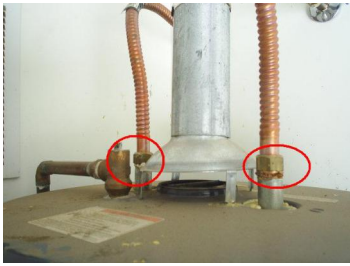
27. Water Heater(s)

The water pipes are corroded; (2)

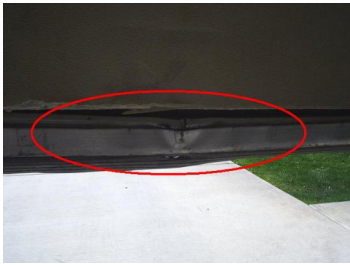
50. Vehicle Door

The damage to the vehicle door was minor. One or more of the door panels is damaged on the right side. (2)

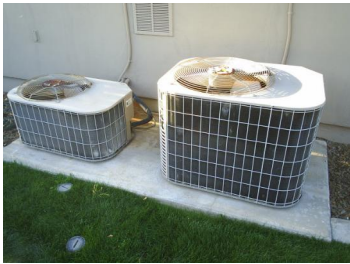
38.2. Air Conditioning

This is a 4 ton unit. The evaporator coil appears to be showing signs of age and damaged, it is still functioning well but it would wise to have regular checkups. (2)

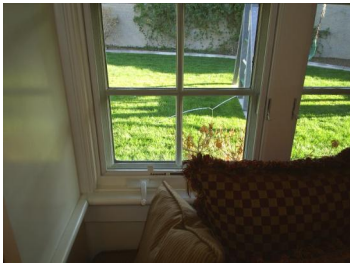
58. Windows

Cracked/broken glass at: living room.

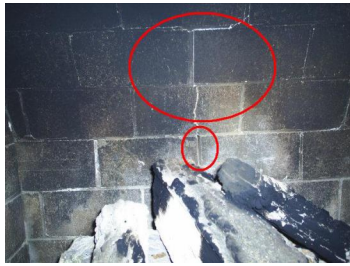
62. Fireplace(s)

There are cracked fire bricks in the fireplace. (2) The mortar joints between the fire brick are deteriorated. (2) Recommend further evaluation and repairs by a qualified professional. (4)

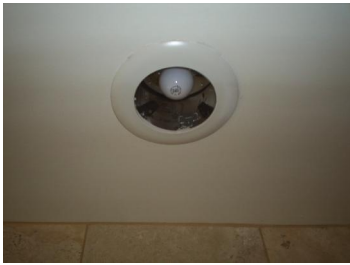
74.3. Electrical

Light above shower should have a plastic protection plate over it to keep moisture and water from entering.

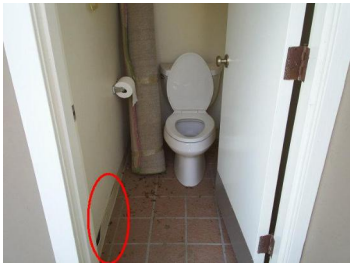
72b.4. Floors

Base border has come loose from wall.
